Results That Sell

Integral Water Repellent Study

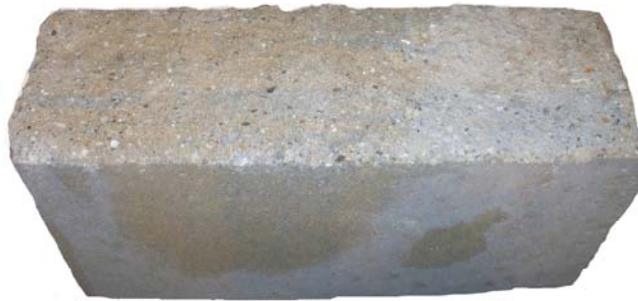
The retaining wall block pictured below was photographed immediately after it was manufactured, already showing haze from the integral water repellent. We applied NMD 80 diluted (4:1) on part of the block to remove the haze. Where the NMD 80 was applied, a uniform color-enhanced appearance is present. We thus encourage cleaning after every installation.

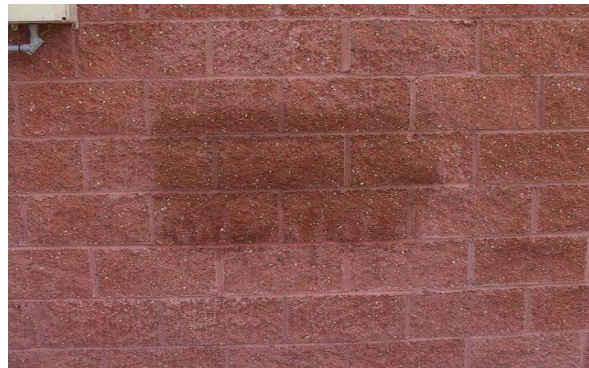
Pictured below is another situation with obvious haze and run marks. The issues are associated with a reaction between internal moisture and the integral water repellent. NMD 80 (4:1) removed the water repellent film that had trapped calcium and allowed internal moisture to freely flow out. The source of the moisture was internal (possibly rain filling the block or wicking from the ground) and with the removal of the film, the wall began to dry out through the vented area.

In the picture, not only is there an apparent haze but water migration has been trapped in the wall due to the integral water repellent. After cleaning, the wall is then able to breathe, allowing moisture that has been trapped to flow freely. It sometimes takes weeks at a time for the wall to completely dry out.

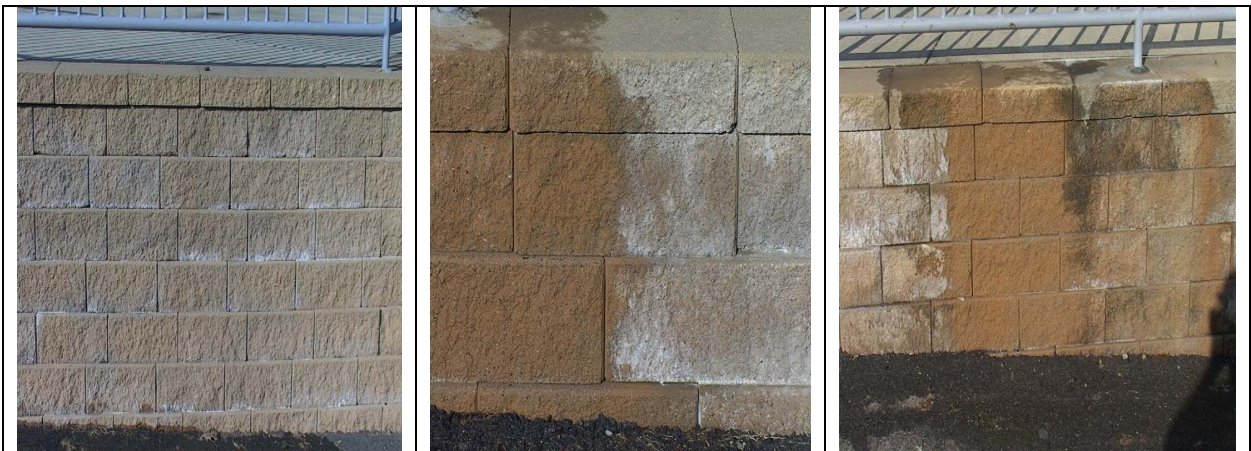
The problem on the block pictured below, while logically assumed to be calcite, is in fact white scum. We almost always see this problem on brick, but not block. Therefore, it was very surprising when our White Scum Presoak cleaner began to dissolve this problem immediately. It was then followed with a double undiluted application of White Scum Presoak, a double application of NMD 80 (cut (4:1) with water), then rinsed with water poured from a gallon jug. This treatment removed 90% of the problem. The procedure was repeated several times just in the areas still showing white and removed 99% of the problem.

Pictures taken a week later reveal that there has been no change in color after the initial clean.

The issue on this particular job is how the white scum was created. We are not privy to the manufacturing process or the block's components, so we can only speculate about the more obvious possibilities.

1. A cleaner was used that reacted with the block, creating white scum.
2. The concrete pad behind the wall may have been poured after the wall was constructed; the cement leached calcium through sand which migrated through the block, leaving the deposit.
3. The colorant used may contain clay. If the aggregate in the block has sand in it, an internal reaction can create white scum as moisture travels through the wall.
