MONTHLY NEWSLETTER FROM EACO CHEM, INC.

Integral Water Repellent and Admixtures!

The Water Test - Easy, Safe and FREE!

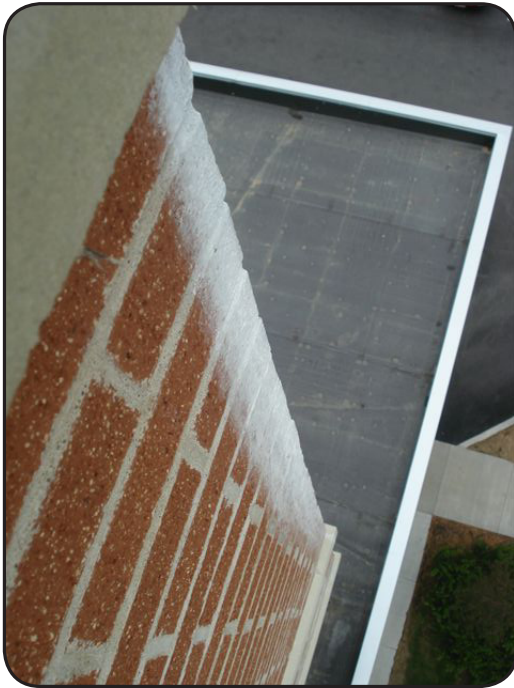
Recent testing has shown us that what may look like calcite or white scum, may in fact be integral water repellent leaching out.

Manufacturers add integral water repellent and admixtures to their masonry. In some cases, the additives can leave a whitish stain on the surface.

We have always approached the removal of these stains with our traditional "Complete Cure" program, starting with EF-Fortless, then moving to Calcite Presoak and White Scum Presoak followed with NMD 80. When the first application of presoak foams, but the second application does not, a different tactic is called for.

We are learning that OneRestore® has been able to successfully remove the stains. In the early stages of testing, OneRestore® has yet to fail.

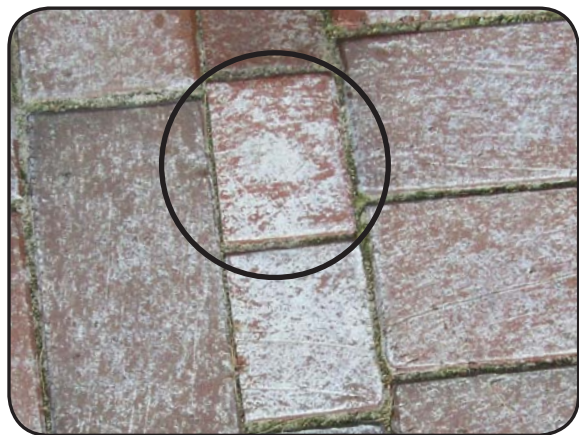
In the above left picture, you can clearly see heavy white deposits. Just by looking at these deposits, it is nearly impossible to determine what we are dealing with. In the picture to the right, water was applied and the stains have faded, but are still clearly visible. This tells us that it is not efflorescence and further testing is required.

The water test is a simple way to determine if you are dealing with efflorescence or another issue. For this test, all you need is a spray bottle with water. If the area is sprayed with water and the stains disappear, your first step will be EF-Fortless. If the stains are still visible after wet, test Calcite Presoak and White Scum Presoak followed by NMD 80 (4:1).
